**CANADIAN FORCES
FLIGHT SAFETY INVESTIGATION REPORT (FSIR)**

FINAL REPORT

FILE NUMBER: 1010-146434 (DFS 2-5)
DATE OF REPORT: 17 March 2006

AIRCRAFT TYPE: CH146 - Griffon
DATE/TIME: 281530Z August 2003
LOCATION: Valcartier Garrison, Québec
CATEGORY: "C" Category Accident

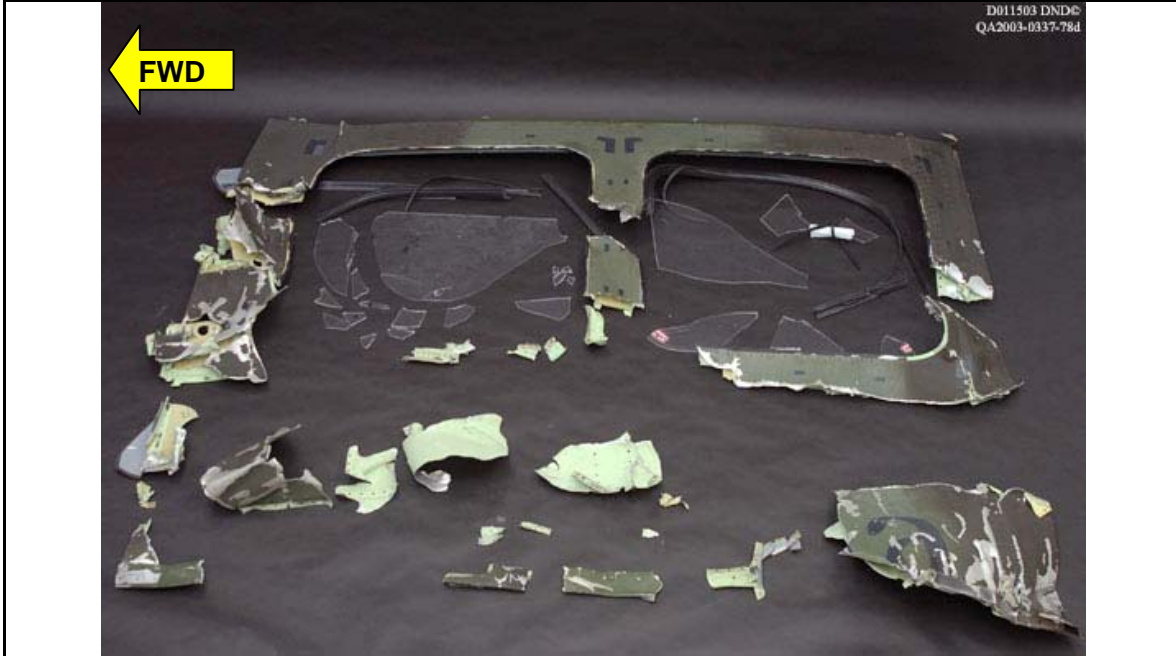
The investigation revealed that after the LH cargo door assembly left the aircraft, it was struck multiple times by the main rotor blades and was cut to pieces and scattered over the administrative area of the Valcartier Garrison. In addition, various scratches and dents were observed along the LH side of the fuselage aft of the LH cargo door. The CH146434, received "C" category damage as a result of the damage sustained by the main rotor blades.

PHOTO 1
Recovered pieces of the LH cargo door of Griffon CH146434.

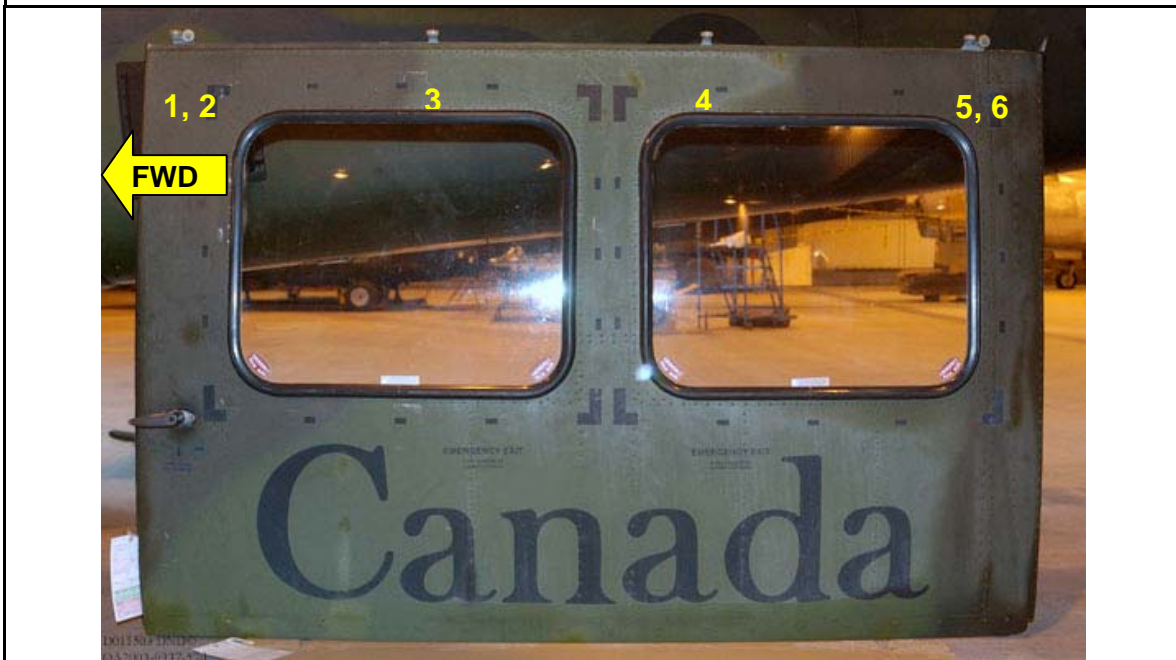
PHOTO 2
Standard CH146 Griffon LH cargo door indicating the roller numbering sequence used.

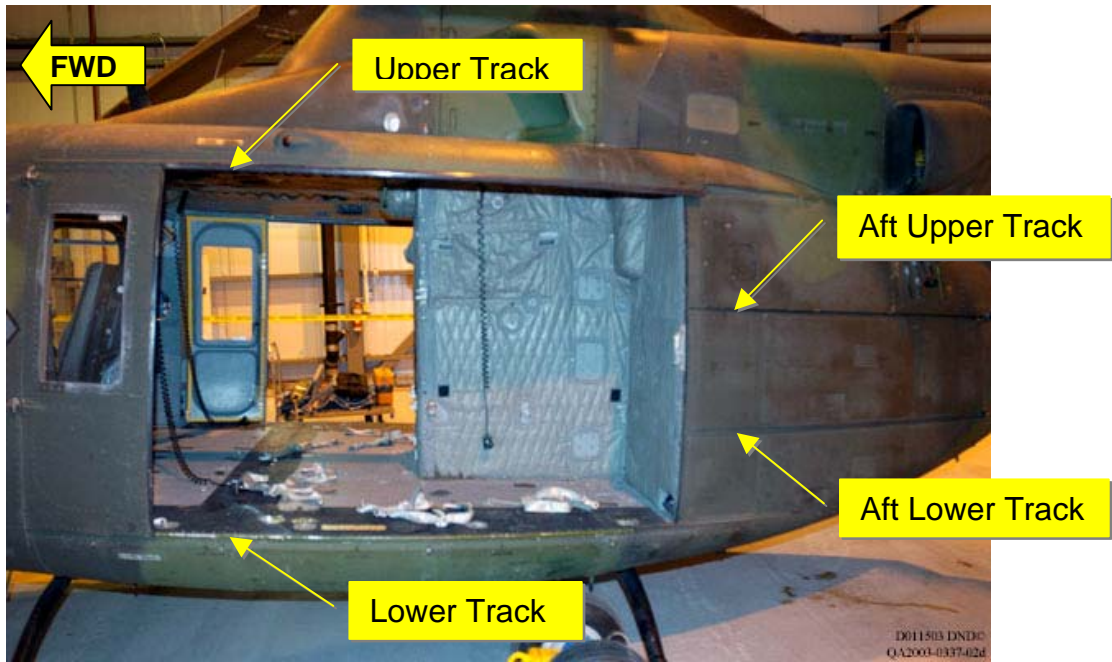
It was determined that all the damage sustained by the aircraft was associated with the LH cargo door departing the aircraft and impacting the fuselage and main rotor blades. The investigation focused on the LH cargo door and all its attachment points. The aircraft tracks and their respective locations are indicated in photo 3 of Annex A.

PHOTO 3
View of LH side of aircraft CH146434 indicating cargo door track locations.

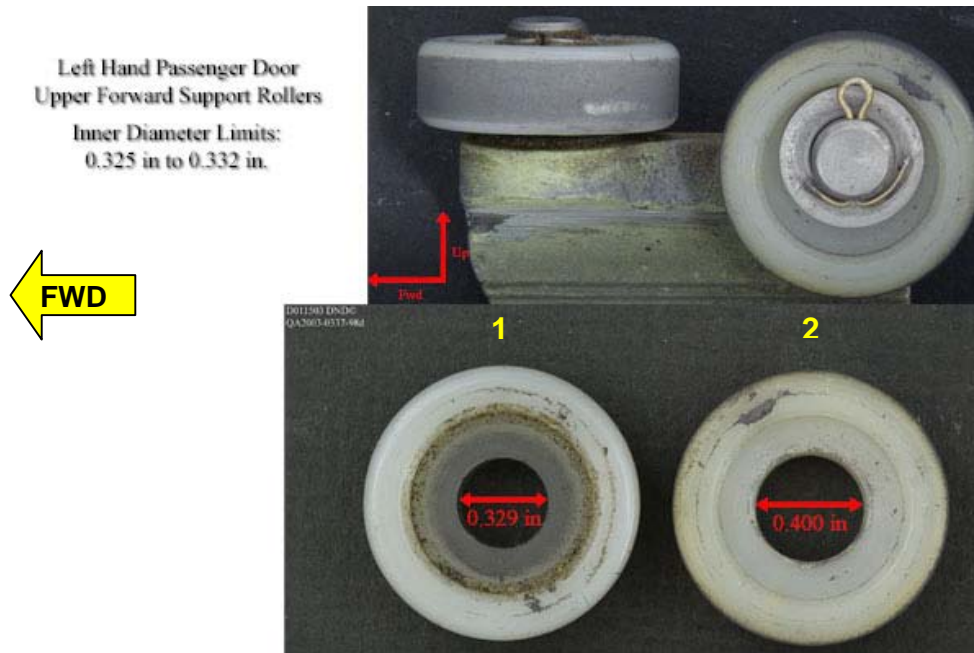
The upper support rollers, part number (P/N) 205-030-437-007, were examined. It was noted that one of the rollers showed significantly more wear of its internal diameter than the other rollers. This wear could be felt by moving the roller against the stem of the roller support. The rollers were removed from the door and numbered one through 6 starting from the most forward roller (see photo 2 of Annex A). The rollers were examined for wear and damage and measurements were taken of the inner and outer diameters. These measurements were compared to those described in the Canadian Government Catalog of Materiel (CGCM) for this item. The CGCM specifications reflect the “as new” manufactured condition of the components and are not “in service” wear limits, but is not an authorized technical reference or source of information for the CH146 parts. However since no other specifications were available, the investigation team believed that it was reasonable to use the CGCM’s dimensions as a reference.

The inner bore diameter of the roller number two exceeded the maximum limit of 0.332 inch by 0.068 inch. The outer diameters of all rollers were within the tolerances of 1.020 inches – 1.040 inches described in the CGCM. The condition of rollers number 1 and 2, installed and removed with their respective measurements can be seen in photo 4 of Annex A.

PHOTO 4
LH cargo door rollers 1 and 2 installed and removed with inner bore diameters indicated.

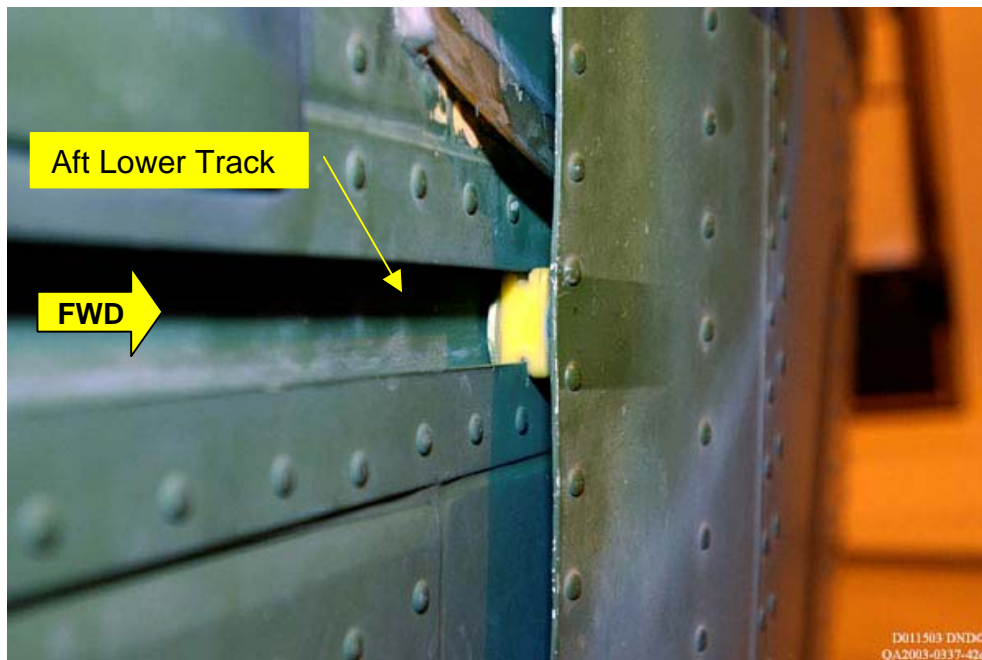
PHOTO 5

The door slide was also examined. A typical door slide, P/N 120-127-4, is shown installed on the RH door of aircraft CH146434 (photo 5, Annex A). The slide appears to have more wear in the lower groove than in the upper groove, which is expected given the downward loading of the door. The recovered door slide from the left hand door of CH146434 had signs of damage that are consistent with the slide being torn from the aft lower fuselage track (photo 6, Annex A). Also, the LH door slide had more wear in its lower groove (photo 7, Annex A), similar to the RH slide.

Yellow object is the lower aft track slide of the RH door of aircraft CH416434. Note the upper groove of the slide is barely in contact with the fuselage track.

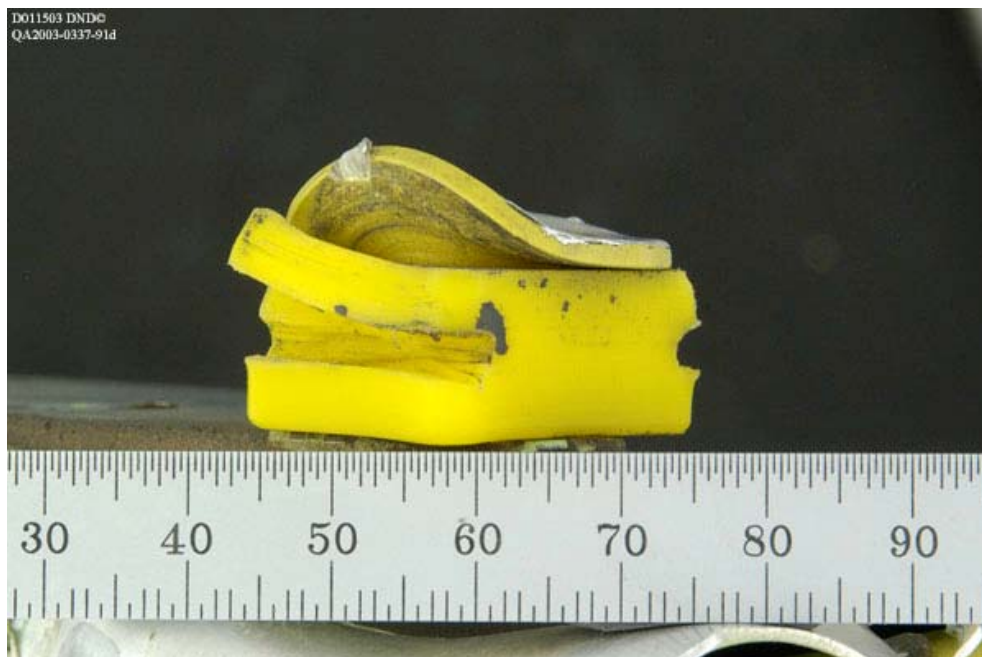
PHOTO 6

LH lower aft cargo door slide from aircraft CH416434. Damage to slide is consistent with being pulled from the aft lower fuselage track

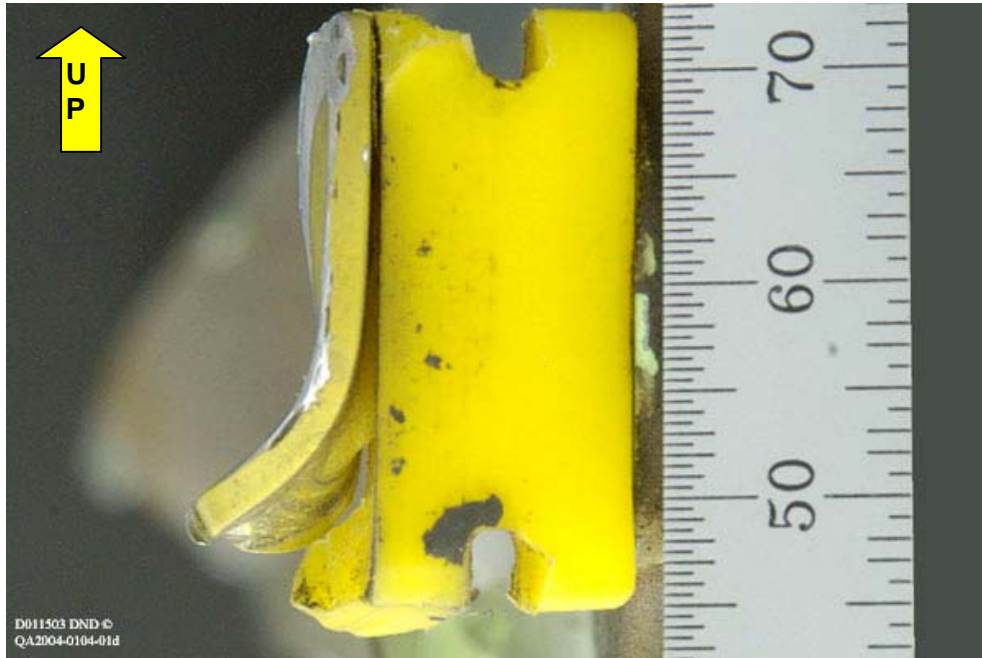
PHOTO 7
LH lower aft channel door slide with lower groove showing more wear than the upper groove.

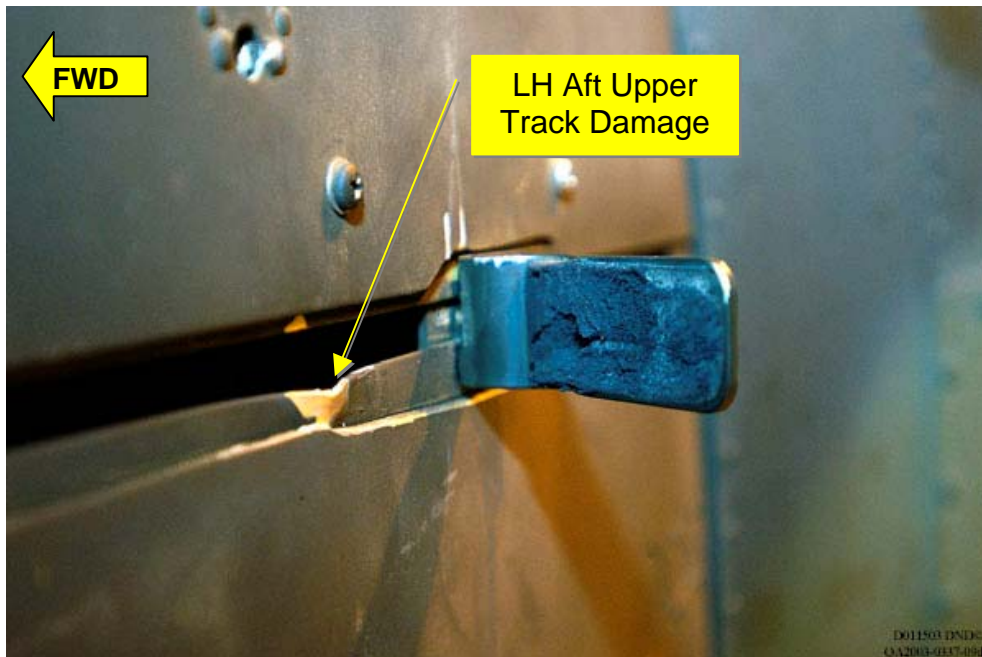
The door support roller runs, P/N 205-030-437-005, in the aft upper track had no signs of damage. The aft upper track had damage that was consistent with the aft upper support roller being pulled from the track during the in-flight departure of the door (photo 8, Annex A).

PHOTO 8
LH aft upper track damage consistent with the upper support roller being pulled from the track during the departure of the cargo door.

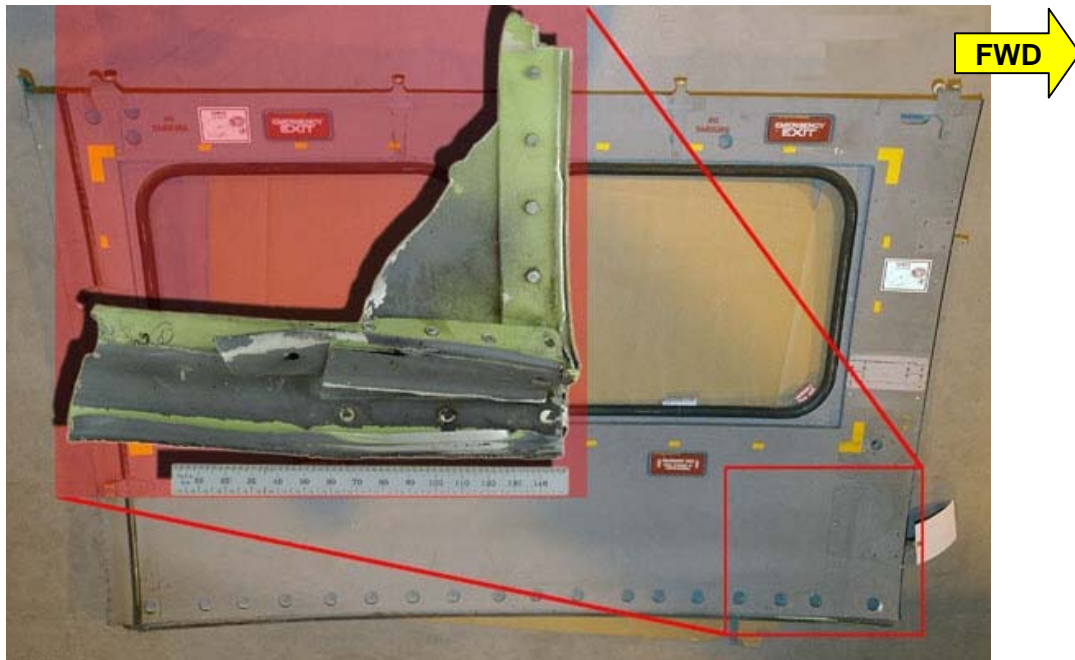
The LH track attached to the bottom of the door was not completely recovered. The most forward portion of the door was recovered (photo 9, Annex A) and two distinct horizontal parallel wear marks were visible and the lower forward 0.75 inch of the door channel had typical in use wear including loss of material (photo 10, Annex A). The upper wear mark was 0.175 inch measured from top to bottom and both marks together measured 0.320 inch. These measurements were noted due to the fact that the lower fuselage tracks are to be engaged by not less than 0.250 inch.

PHOTO 9
Inboard surface of recovered lower fwd corner of the LH cargo door.

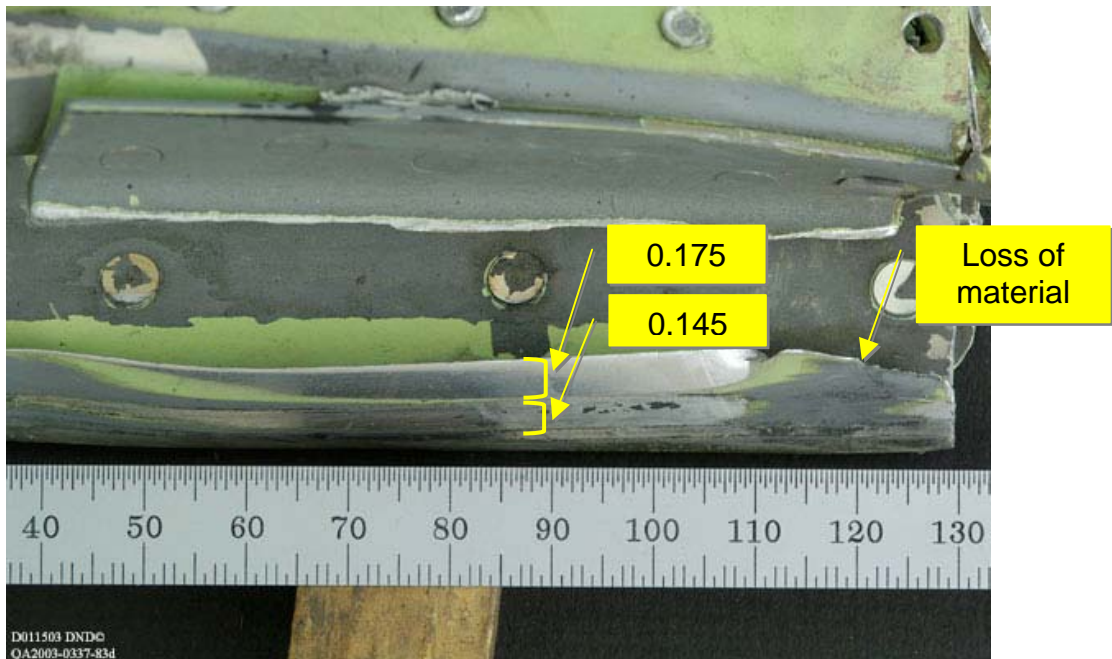
The two parallel horizontal rub marks on the door channel provide further indications of the door being in a lower position when the door is fully aft. The 0.320 inch wear mark is most likely the wear mark when the door is in the full forward position and being supported by upper rollers number two and six and by the lower aft slide. The 0.175 inch wear mark is most likely a result of the door being in the full aft or open position and riding only on the worn roller number two and the aft lower slide. The minimum overlap of 0.250 inch is met when the door is full forward or closed but is not met when the door is full aft or open.

PHOTO 10
Close up of recovered inboard surface of lower fwd corner of the LH cargo door with two distinct horizontal parallel wear marks.

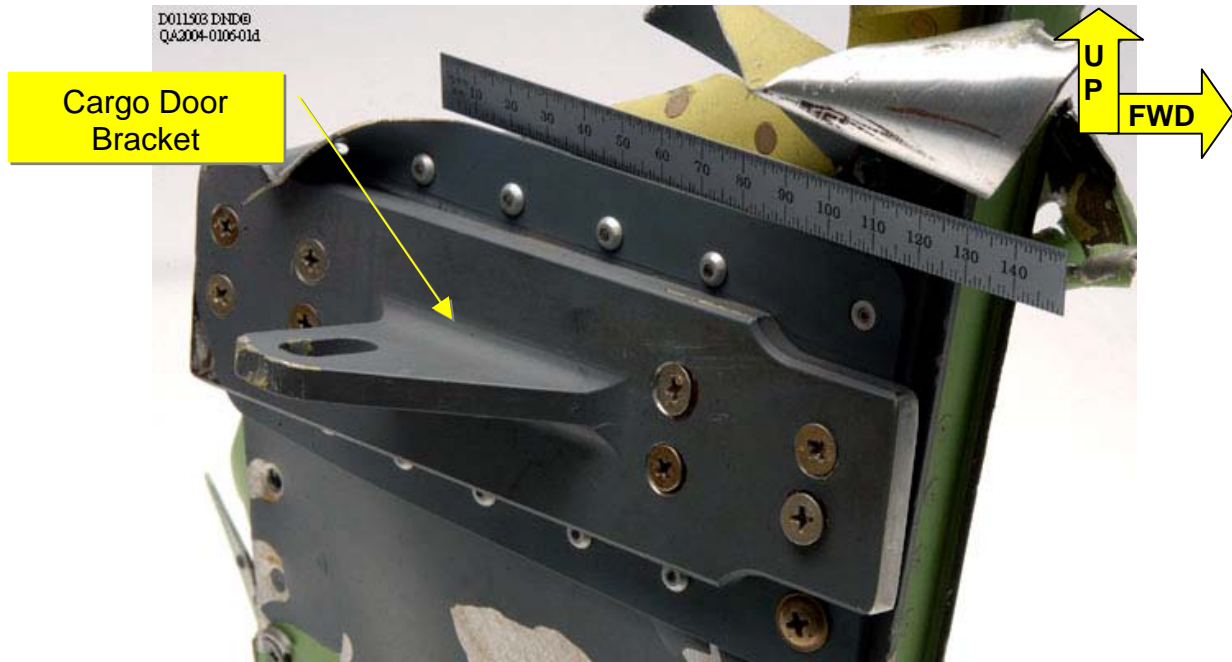
PHOTO 11

The holdback bracket on the LH cargo door was recovered and was not damaged or distorted (photo 11, Annex A). This bracket in combination with a mating bracket and pin on the fuselage enable the door to be pinned in the open

The door portion of the LH door holdback bracket from aircraft CH146434 with no obvious damage or distortion.

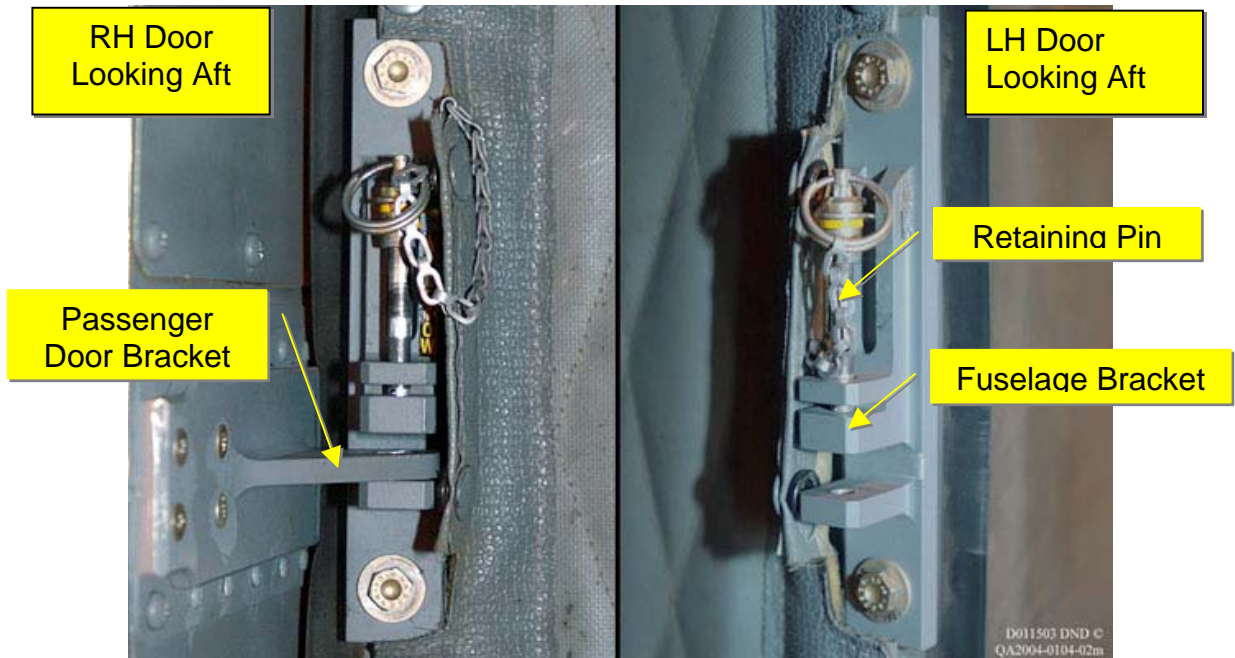
PHOTO 12

position (photo 12, Annex A). This physical evidence supports the FE statement that the left and right cargo doors were not pinned back.

RH and LH holdback bracket of aircraft CH146434 with the RH door in the full back and unpinned condition. The LH door was in this state at the time the door departed the aircraft.

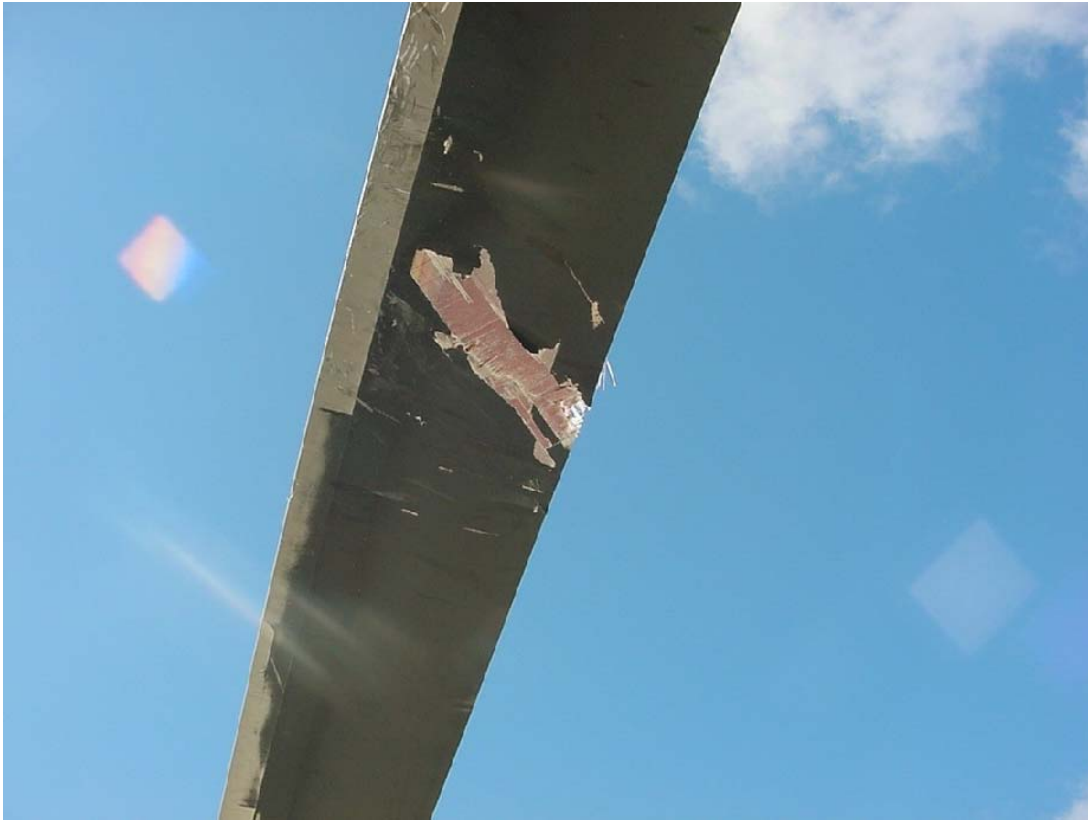
PHOTO 13
Damage to one of the main rotor blade from aircraft CH146434.
